APPROVAL OF THE DEVELOPED VISUAL ASSESSMENT OF SEISMIC RESISTANCE, TAKING INTO ACCOUNT THE IRREGULAR WALL INFILL

Abstract. The purpose of this article is to test the proposed methodology for the visual assessment of the earthquake resistance of buildings with flat slab frame, taking into account the influence of non-structural wall infill. The object of study is located in 126, Tolbukhin Street in Odessa. Visual assessment is a method of expert assessment which includes a visual inspection of the building using a specially designed form that takes into account the main parameters that determine the level of building earthquake resistance. Such an assessment formalizes the expert approach to the research, and due to this, significantly reduces the time period necessary to determine the earthquake resistance of a building.

In the Table. 1 is a form for assessing the seismic stability of an object.

Table – 1 Form of seismic assessment of the object

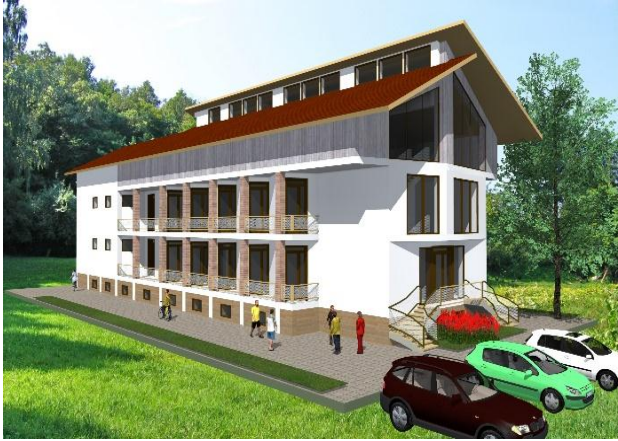
(Characteristic view, form a general idea of the object)		Address – 126, Tolbukhin str., Number of floors – 3 Building area, m ² – 1200 Erection year – 2014 Purpose – Residential The cost of the object according to DSTU 8855: 2019 (in minimum wages) – 734 The class of consequences [3] – CC2 Seismicity of the site – 7 Category of soils by seismic properties – II Other

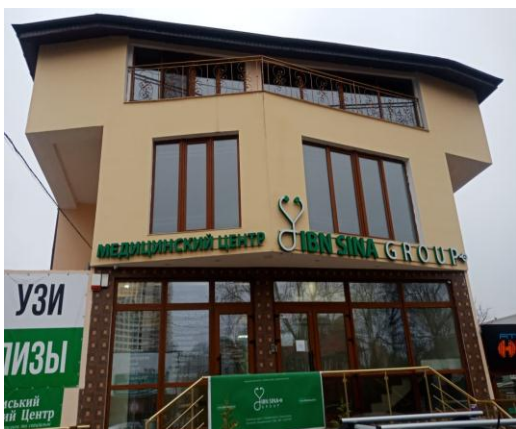
Facade 1

<p style="text-align: center;">Facade 3</p>	<p style="text-align: center;">Facade 4 access to the rear facade was not provided</p>
<p>Photo fixation of detected critical criteria of the object (if detected)</p>	
<p>Critical criteria no. 10, 11, 13.2, 13.4, 13.6 are visible on facades no. 1 and no. 2</p>	
<p>Expert opinion</p>	
<p>The facility is potentially non-seismic and requires certification (Level 2 SOFS)</p>

Research results. Given that visual assessment of seismic stability is a part of a three-tier system for assessing actual seismic stability, a further, more detailed, inspection of the object by means of passporting is required in the first step when detecting a seismic deficit.
