**BEARING CAPACITY, DEFORMITY AND CRACK RESISTANCE OF DAMAGED BEAMS REINFORCED WITH FIBER CONCRETE**

**Purpose.** The purpose of the work was experimental studies of the load-bearing capacity, deformability and crack resistance of damaged beams reinforced with fiber concrete in the compressed and stretched zone.

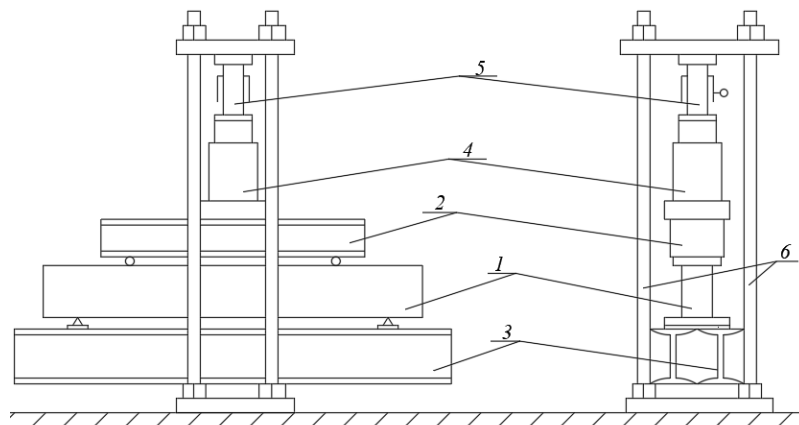
Fig. 1. Test bench: 1 – the beam being tested; 2 – traverse; 3 – the lower load beam (I-beams); 4 – jack; 5 – sample dynamometer; 6 – racks

**Research results.** In accordance with the research program of bearing capacity, deformability and crack resistance of damaged reinforced concrete beams reinforced with steel fiber concrete, a bench for testing reinforced concrete beams was developed at the departments of construction mechanics and resistance of materials. The flat transverse bending of the load of the tested beam is created with the help of a hydraulic jack and a metal beam with a two-beam traverse, which transmits two equal concentrated forces to the beam. The load created is controlled by a sample dynamometer of the Tokar system and a ring dynamometer that acts as a support (Fig. 1).

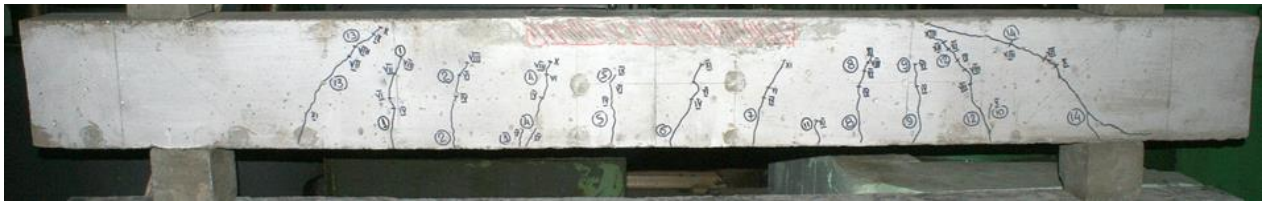
Fig. 3. Cracks in the sample RCD3

Cracking started at the 4th loading stage, when the load value was 26.0kN, i.e. 28.3% of the bearing capacity of the damaged beam. At the same time, 5 cracks formed in the area of pure bending. At the fifth stage, two more cracks appeared. At the 8th and 9th loading stages, 4 more cracks formed. A total of 12 cracks were formed. The maximum final crack opening width was 0.6 mm. General indicators of crack formation are given in Table 3.

The destruction of the sample started with crack 11. The general appearance of the cracks formed at the end of the RCD3 sample tests is shown in Fig. 3.

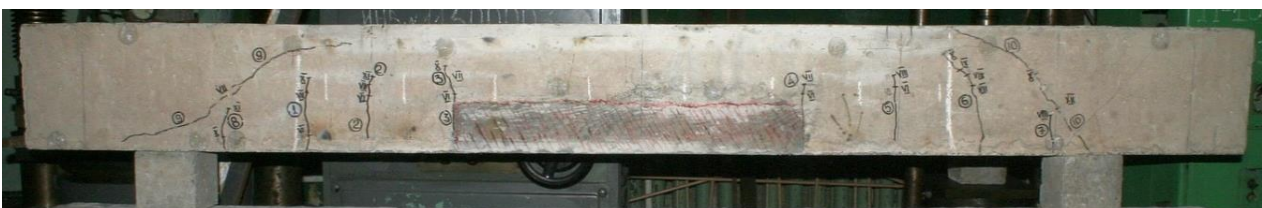
Fig. 4. Cracks in the sample RCD5

Cracking started at the 5th stage of loading, when the load value was 32.5kN, i.e. 35.2% of the bearing capacity of the damaged beam; the first crack appeared. Another one is at the second stage. At stages 7-9 of loading, 8 more cracks formed, and at stages 11-14, the last six. 4 cracks formed in the zone of clean bending. The total number is 19 cracks. The maximum final crack opening width was 0.8 mm. General indicators of crack formation are given in Table 4.

The destruction of the sample began with crack 13.

The general appearance of the cracks formed at the end of the RCD5 sample tests is shown in Fig. 4.
