APPROVAL OF THE DEVELOPED VISUAL ASSESSMENT OF SEISMIC RESISTANCE, TAKING INTO ACCOUNT THE IRREGULAR WALL INFILL

Abstract. The purpose of this article is to test the proposed methodology for the visual assessment of the earthquake resistance of buildings with flat slab frame, taking into account the influence of non-structural wall infill. The object of study is located in 126, Tolbukhin Street in Odessa. Visual assessment is a method of expert assessment which includes a visual inspection of the building using a specially designed form that takes into account the main parameters that determine the level of building earthquake resistance. Such an assessment formalizes the expert approach to the research, and due to this, significantly reduces the time period necessary to determine the earthquake resistance of a building.

In the Table. 1 is a form for assessing the seismic stability of an object.

Table – 1 Form of seismic assessment of the object

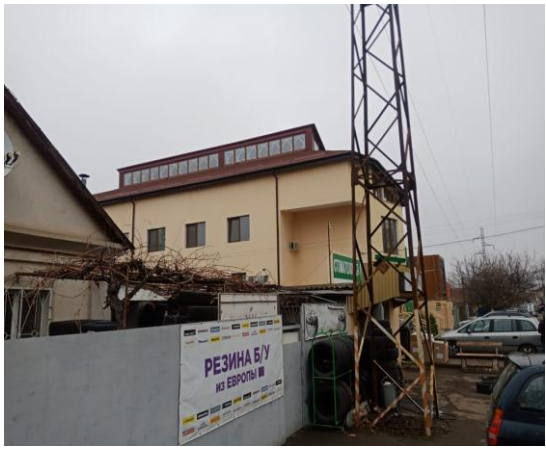
Facade 2

<p style="text-align: center;">Facade 3</p>	<p style="text-align: center;">Facade 4 access to the rear facade was not provided</p>
<p>Photo fixation of detected critical criteria of the object (if detected)</p>	
<p>Critical criteria no. 10, 11, 13.2, 13.4, 13.6 are visible on facades no. 1 and no. 2</p>	
<p>Expert opinion</p>	
<p>The facility is potentially non-seismic and requires certification (Level 2 SOFS)</p>
